**State of Louisiana
Coastal Protection and Restoration Authority**

2016 Annual Inspection Report

Jonathan Davis Wetland Protection

State Project Number BA-20
Priority Project List 2

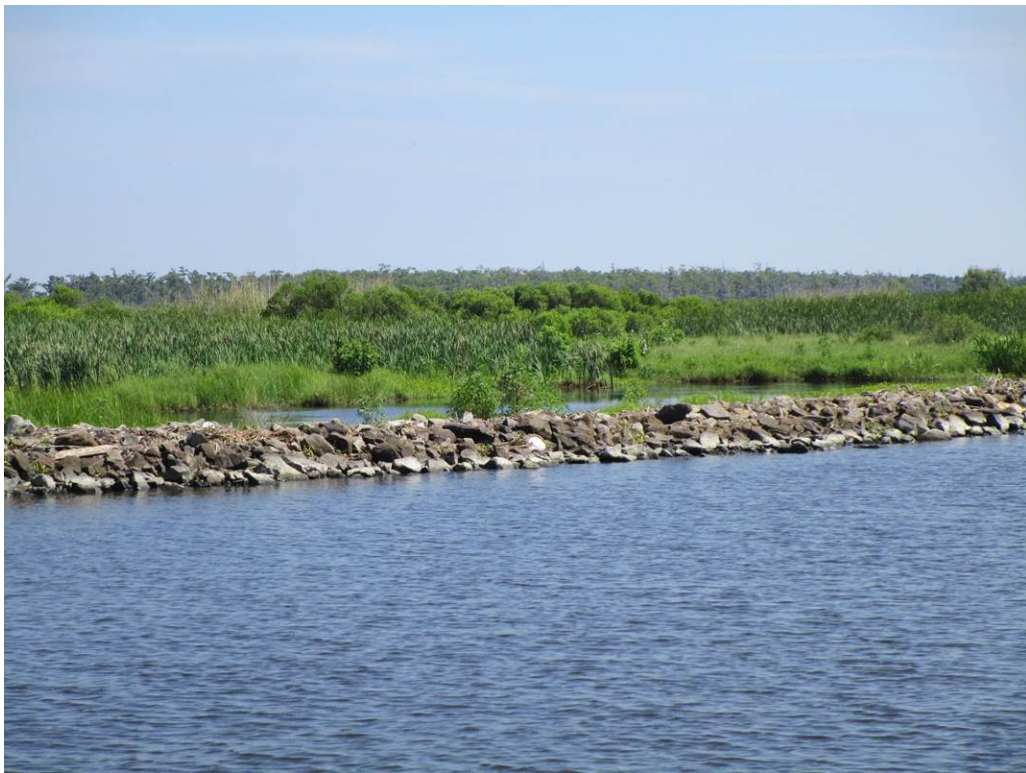
Photo #1 – Bayou Perot Shoreline Protection (CU3)

No significant changes were noted since the last inspection. The rock shoreline protection appeared to be in good condition, with minor settlement in some areas. The areas of lower elevation deserve continued observation on future inspections, but no maintenance needs were identified at this time.

Item	Condition	Physical Damage	Corrosion	Photo #	Observations and Remarks
Rock Dike	Good; see remarks	None	N/A	1	Minor settlement observed in some areas, no repairs needed at this time.
Construction Unit No.3 Structure Description: The rock dike consist of 13,088 linear ft. of rock dike with a 6 ft. top width and a crest elevation of +3.5 ft. The shoreline stabilization extends from Site 12 west to the Gulf Intracoastal Waterway

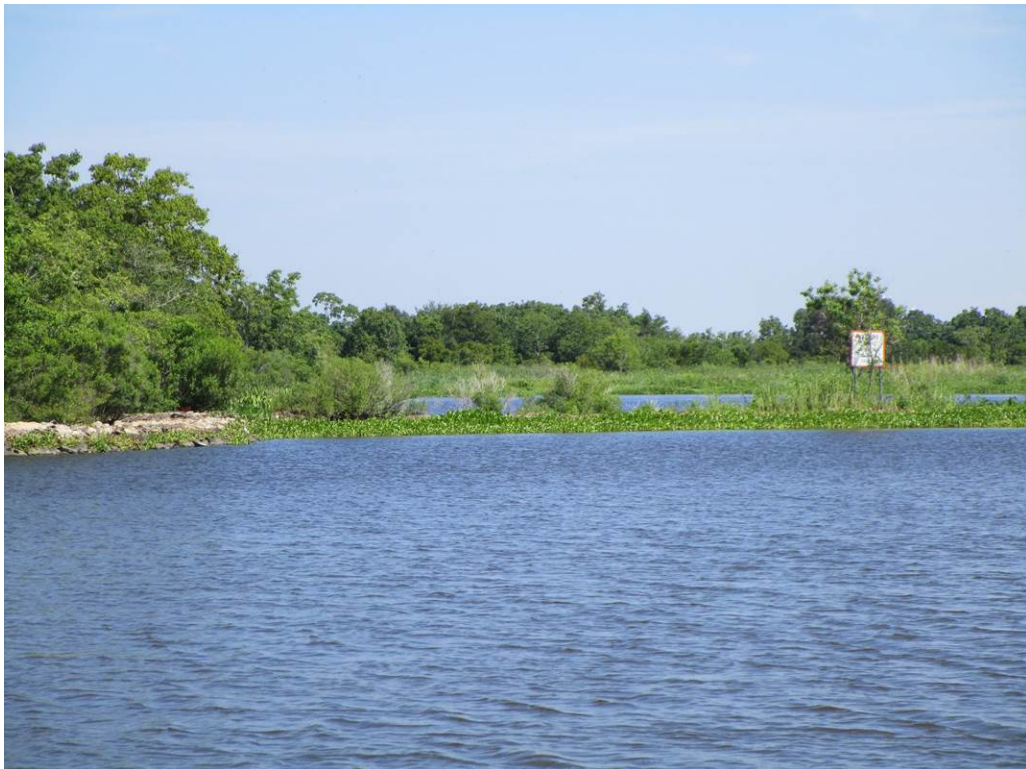
Photo #2 – Structure #12

Minor settlement has occurred, but the structure is in good condition. No maintenance needs were identified at this location.

Item	Condition	Physical Damage	Corrosion	Photo #	Observations and Remarks
Signage and supports	Good	None	None	2	
Armored plug	Good	None	N/A	2	No change since last inspection; maintenance not required at this time.
Construction Unit No.1 Structure Description: 294 linear ft. rock rip-rap armored rock-filled plug located in a pipeline channel north of Bayou Perot, west of Bayou Barataria, and east of the GIWW. The crest of the weir was set at an elevation of +3.9 ft. NGVD. The rock-filled plug contains 2,689 tons of rock filled with 2,518 tons of rip-rap armor. Aluminum warning signs are also located in the rock embankment.

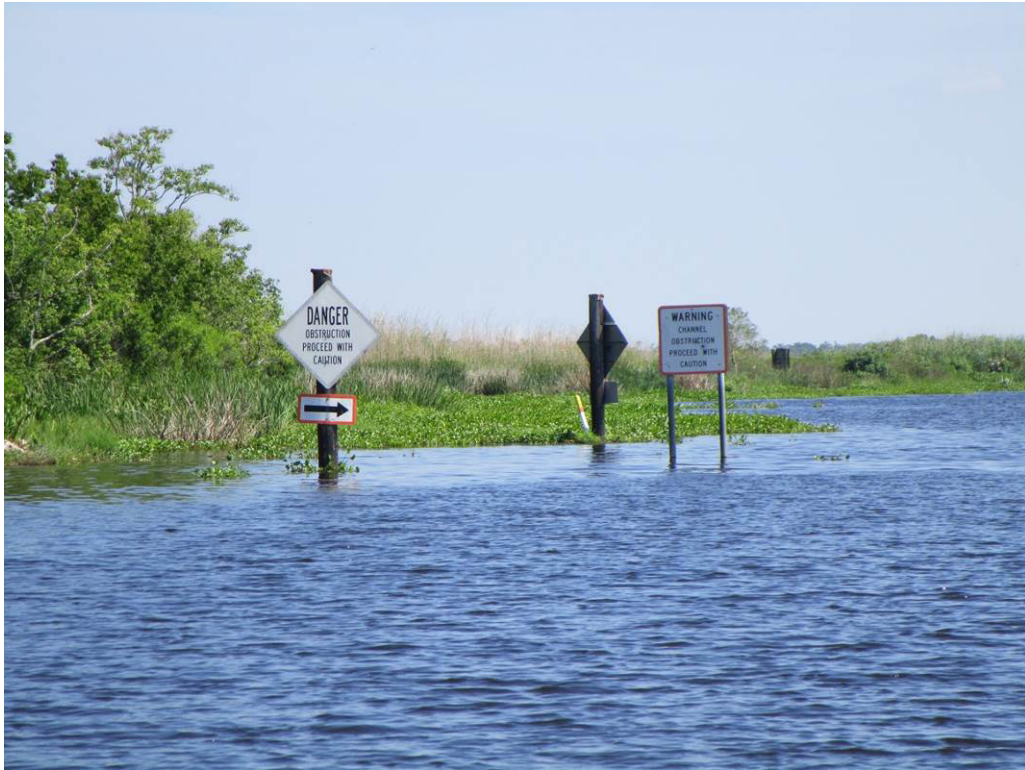
Photo #3 – Structure #13

High water levels and structure settlement prevented a detailed inspection of the weir. Signs and timber supports were generally in good condition. No maintenance will be required at this time.

Item	Condition	Physical Damage	Corrosion	Photo #	Observations and Remarks
Signage and supports	Good			3	
Armored Weir	Fair			3	Structure has experienced some settlement, but maintenance is not required at this time.
Construction Unit No.1 Structure Description: 300 linear ft. rock rip-rap armored rock filled weir with a 50 ft. wide boat bay located north of Bayou Perot and Site 12, west of Bayou Barataria, and east of the GIWW. The crest of the weir is set at an elevation of +1.0 ft. NGVD. The invert of the boat bay is set at an elevation of -5.0 ft. NGVD. Rock wingwalls were constructed to an elevation of +3.6 ft. NGVD. on the west side and +4.0 ft. NGVD on the east side of the weir. The rock filled weir contains 1,093 tons of rock fill and 772 tons of rip-rap armor. Aluminum warning signs are located adjacent to the structure.

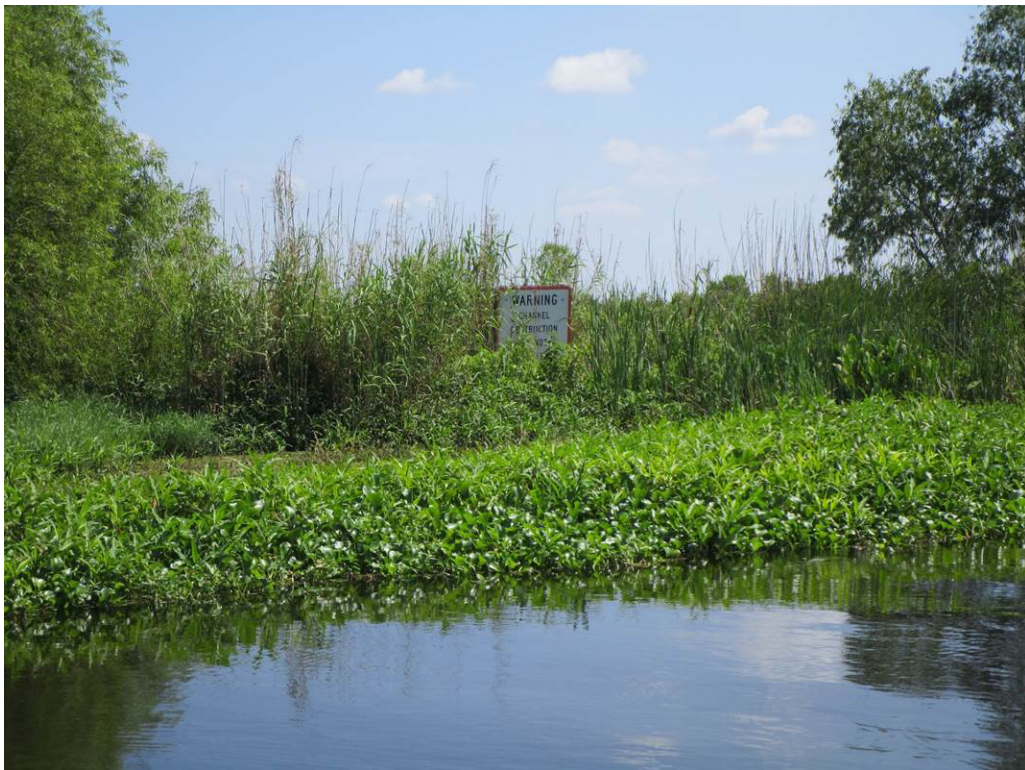
Photo #4 – Structure #14

Structure was in good condition, with some settlement noted. There is currently no need for maintenance on this structure.

Item	Condition	Physical Damage	Corrosion	Photo #	Observations and Remarks
Signage and supports	Good			4	Observations:
Armored Plug	Good			4	Slight settlement noted, but no repairs needed at this time.
Construction Unit No.1 Structure Description: 138 linear ft. of rock rip-rap armored rock filled channel plug located in a pipeline channel north of Bayou Perot, west of Bayou Barataria and east of GIWW and Site 13. The crest of the plug was constructed to an elevation of +3.2 ft. NGVD. The rock filled plug contains 2,580 tons of rock fill and 1,346 tons of rock rip-rap armor. Aluminum warning signs are located through the rock embankment.

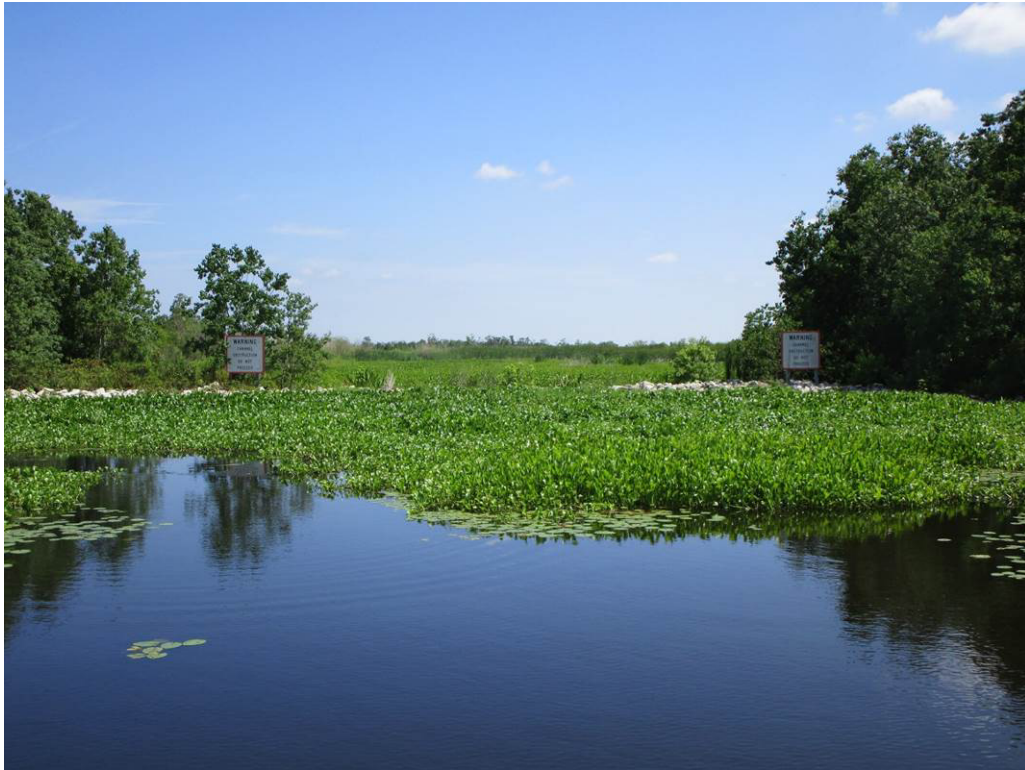
Photo #5 – Structure #15

Weir was converted to a rock plug structure as part of the work effort for Construction Unit 4. No defects were noted during the inspection.

Item	Condition	Physical Damage	Corrosion	Photo #	Observations and Remarks
Signage and supports	Good	None	None	5	
Armored Plug	Good	None	N/A	5	This structure was converted into a channel plug as part of the completed CU4 maintenance work.
Construction Unit No.1 Structure Description: 132 linear ft. of rock rip-rap armored weir with a 50 ft. wide boat bay located in a pipeline channel north of Bayou Perot, west of Bayou Barataria and east of the GIWW and Site 14. The crest of the rock weir was constructed to an elevation of +4.0 ft. NGVD. The invert of the boat bay is at an elevation of -3.0 ft. The rock filled weir contains 1,248 tons of rock fill with and 728 tons of rock rip-rap armor. Two (2) aluminum warning signs are located through the rock armored embankment on each side of the boat bay.

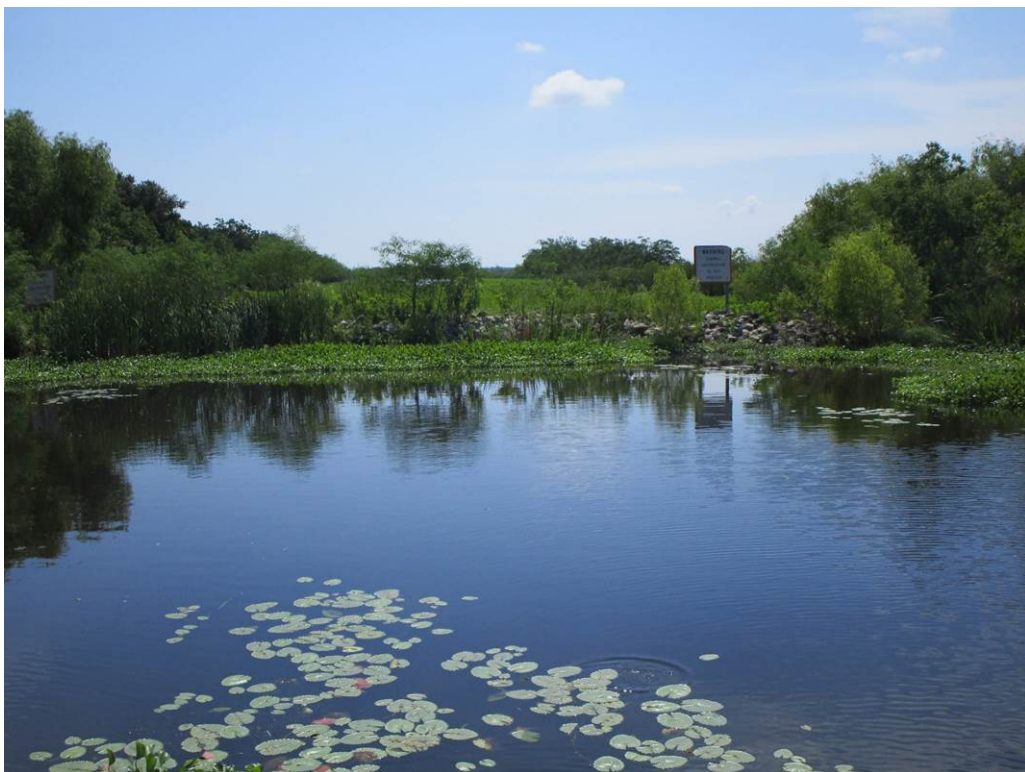
Photo #6 – Structure #16

Rip-rap and warning signs appeared to be in good condition. No immediate maintenance requirements were identified at this structure.

Item	Condition	Physical Damage	Corrosion	Photo #	Observations and Remarks
Signage and supports	Good	None	None	6	
Armored Plug	Fair	None	N/A	6	No maintenance needs identified at this time.
Construction Unit No.1 303 linear ft. of rock rip-rap armored rock filled plug located in a pipeline channel north of Bayou Perot, west of Bayou Barataria, east of the GIWW and Site 15. The crest of the plug was constructed to an elevation of +4.0 ft. NGVD. The rock filled plug contains 6,483 tons of rock fill and 1,766 tons of rock rip-rap armor. Two (2) aluminum warning signs are located through the rock plug embankment.

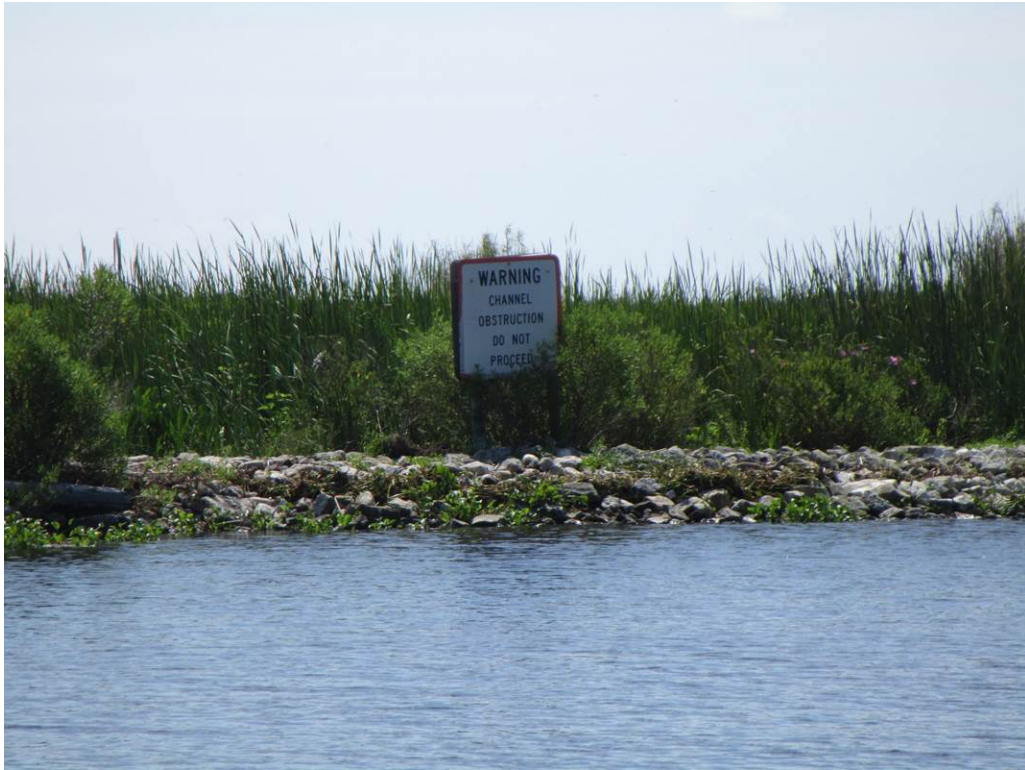
Photo #7 – Structure #17

Plug appeared to be in good condition, with no maintenance needed at this time.

Item	Condition	Physical Damage	Corrosion	Photo #	Observations and Remarks
Signage and supports	Good	None	None	7	
Armored Plug	Good	None	N/A	7	No maintenance is required at this time.
Construction Unit No.1 Structure Description: 197 linear ft. of rip-rap armored rock plug located in a pipeline channel north of Bayou Perot, west of Bayou Barataria, and east of the GIWW. The crest of the plug was constructed to an elevation of 3.8' NAVD. The rock plug was constructed from 2,253 tons of rock fill and 1,201 tons of rip-rap armor. Aluminum warning signs supported by galvanized pipe are located in the rock embankment.

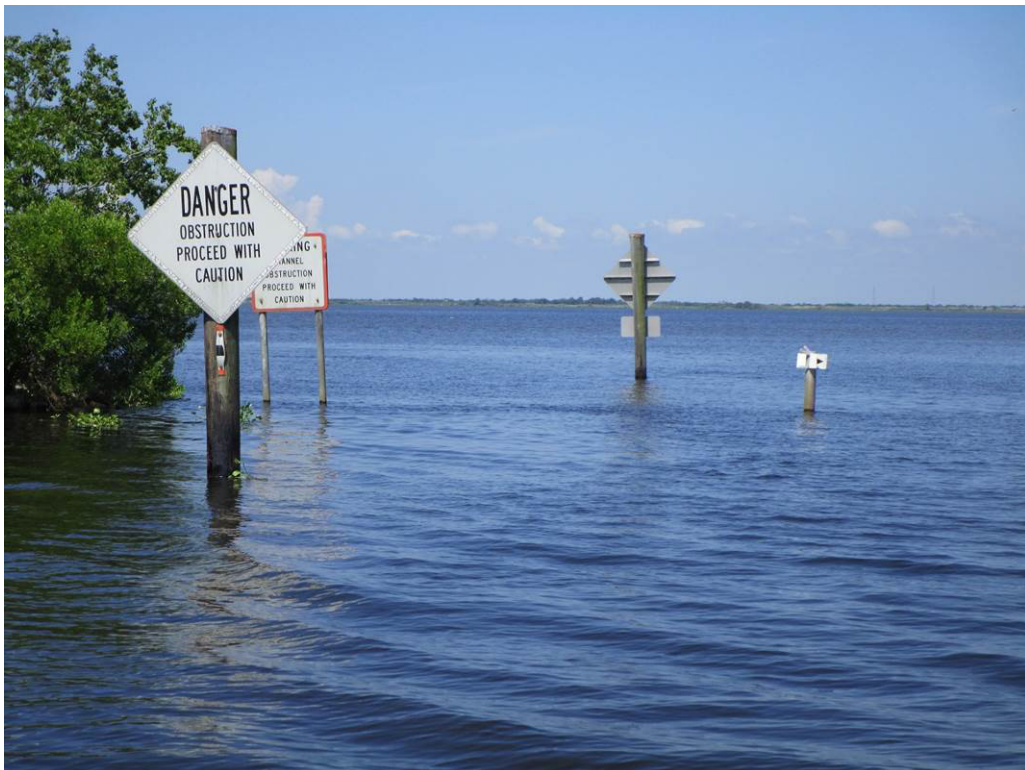
Weir has experienced some settlement, but is performing as designed. One of the warning sign directional arrows had been torn from the timber support pile, and a second arrow was severely bent. These signs will require maintenance.

The project is protecting the shoreline as intended. Structures appeared to be in generally good condition, with the exception of the two damaged/missing signs at Structure #19. NRCS and CPRA agree that the damaged signs will be repaired or replaced from spares on-hand at CPRA's New Orleans Regional office.

Photo #8 – Damaged Signs at Structure #19

Item	Condition	Physical Damage	Corrosion	Photo #	Observations and Remarks
Signage and supports	Fair	See remarks	Minor	8	One of the directional arrow signs was missing, and a second arrow sign was damaged.
Armored Weir	Good	None	N/A	8	No change since last inspection; no maintenance needs were identified.
Construction Unit No.1 Structure Description: 239 linear ft. of rock rip-rap armored rock filled fixed crest weir with a 60 ft. wide boat bay located in a pipeline channel east of the GIWW, north of Bayou Perot, and west of Bayou Barataria. The crest of the weir was constructed to an elevation of +1.9 ft. NGVD on the north side and +2.0 ft. NGVD on the south. The boat bay invert was constructed to an elevation of -2.5 ft. NGVD. The rock filled plug contains 1,014 tons of rock fill with 572 tons of rock rip-rap armor. Aluminum warning signs are located on each side of the boat bay through the rock embankment.

Maintenance repairs should be performed on the Structure #19 warning signs at the earliest opportunity. Continue to inspect and assess project conditions annually.

- Rehabilitate the warning signs at Structure #19.

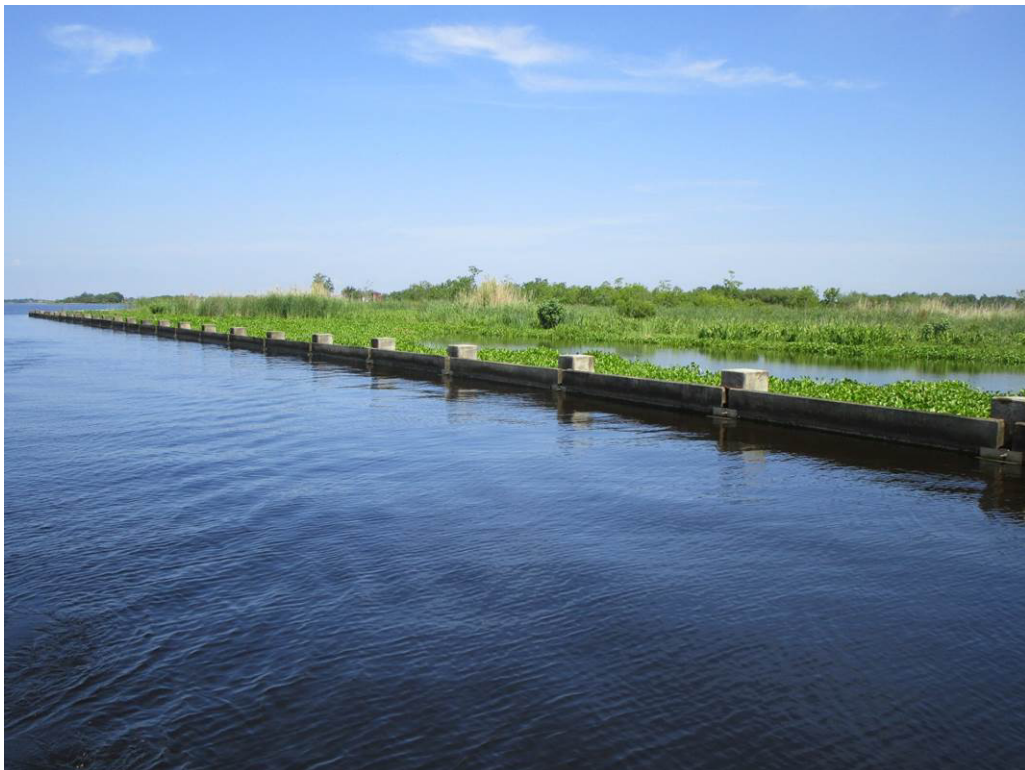
Photo #10 – Panel Wall Shoreline Protection (CU4)

No defects in the concrete panel wall sections were noted; the structure appeared to be in good condition. Minor damage/vandalism to some warning signs was noted, but all signs and timber supports are in place and performing as designed. No immediate maintenance needs were identified at this construction unit.

Item	Condition	Physical Damage	Corrosion	Photo #	Observations and Remarks
Signage and supports	Good	See remarks	Minor		Some fading noted, minor spray-paint vandalism to border of one sign was observed. Sign faces and text were legible; no repairs needed at this time.
Concrete wall panels, piles, hardware	Good	None	None	10	No defects noted; structure was performing as designed.
Rock Dike	Good	None	N/A	9	No defects noted; structure was performing as designed.
Construction Unit No.4 Structure Description: The wall consists of approx. 12,850 linear ft. of pre-cast concrete wall sections supported by 848 pre-cast concrete piles, in addition to approx. 4,290 linear feet of rock rip-rap bank stabilization/shoreline protection. C.U. #4 extends across the northern edge of Bayou Rigolettes and Bayou Perot, from just east of Structure #12 to Structure #20.

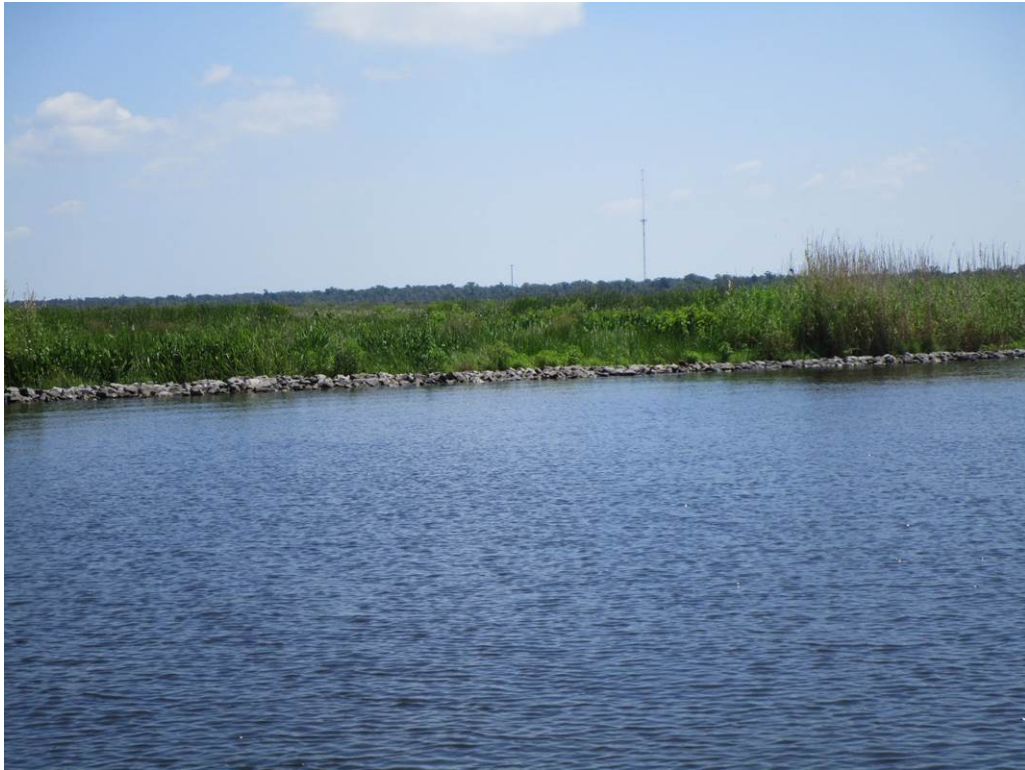
Photo #11 – Bayou Rigolettes Shoreline Protection (CU2)

The rock appears to be in good condition. Minor settlement was observed near the western end of this feature, but the shoreline protection function was being adequately performed. This area should be monitored on future inspections, but no immediate maintenance is required.

Item	Condition	Physical Damage	Corrosion	Photo #	Observations and Remarks
Rock Dike	Good; see remarks			11	Minor settlement observed in some areas, no repairs needed at this time.
Construction Unit No.2 Structure Description: The rock dike consist of 3,967 linear ft. of rock dike with a 6 ft. top width and a crest elevation of +3.5 ft. The shoreline stabilization extends from Site 22A west to Structure No.20.

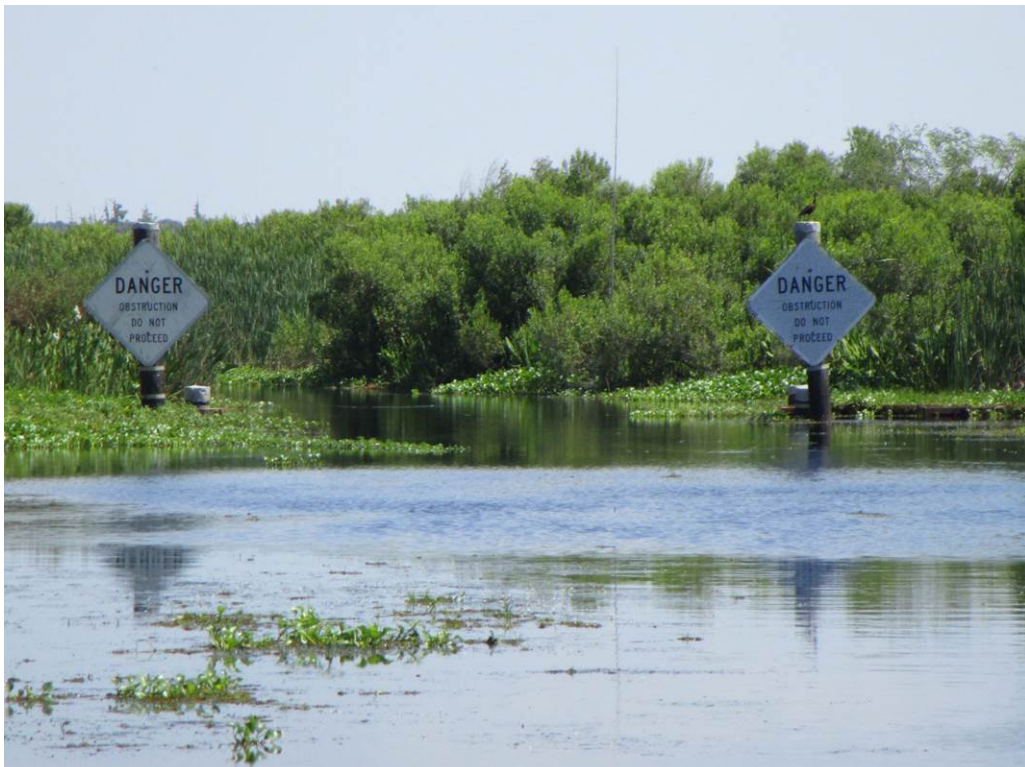
Photo #12 – Structure #22

Weir was partially obscured by aquatic vegetation, but no significant defects were noted on the visible portion of the structure. Warning signs and supports were in good condition. No maintenance is required at this time.

Item	Condition	Physical Damage	Corrosion	Photo #	Observations and Remarks
Steel Bulkhead	Good	None	Minor	12	No significant defects noted. Structure does not require maintenance at this time.
Handrails, Hardware, etc.	Good	None	None	12	
Signage and supports	Good	None	None	12	
Earthen Wingwalls	Good	None	N/A		
Rock Armored Earthen Embankment	Good	None	N/A		
Construction Unit No.2 Structure Description: 58 linear ft. of steel sheet pile bulkhead with a crest elevation of +1.95 ft. and a 24' - 8-1/2" wide boat bay with a crest elevation of -0.93 ft. located off of Bayou Regolettes, west of Bayou Barataria and east of GIWW. The structure consists of a steel sheet pile weir with 1,426 square feet of sheet piling set at +1.95 ft. At the bottom the boat bay, is a 1.5 ft. thick rock rip-rap scour pad section with an invert of -0.93 ft. This structure ties into structure 22A on the west side. Aluminum warning signs supported by 12" diameter timber piles are located at the entrance of the boat bay.

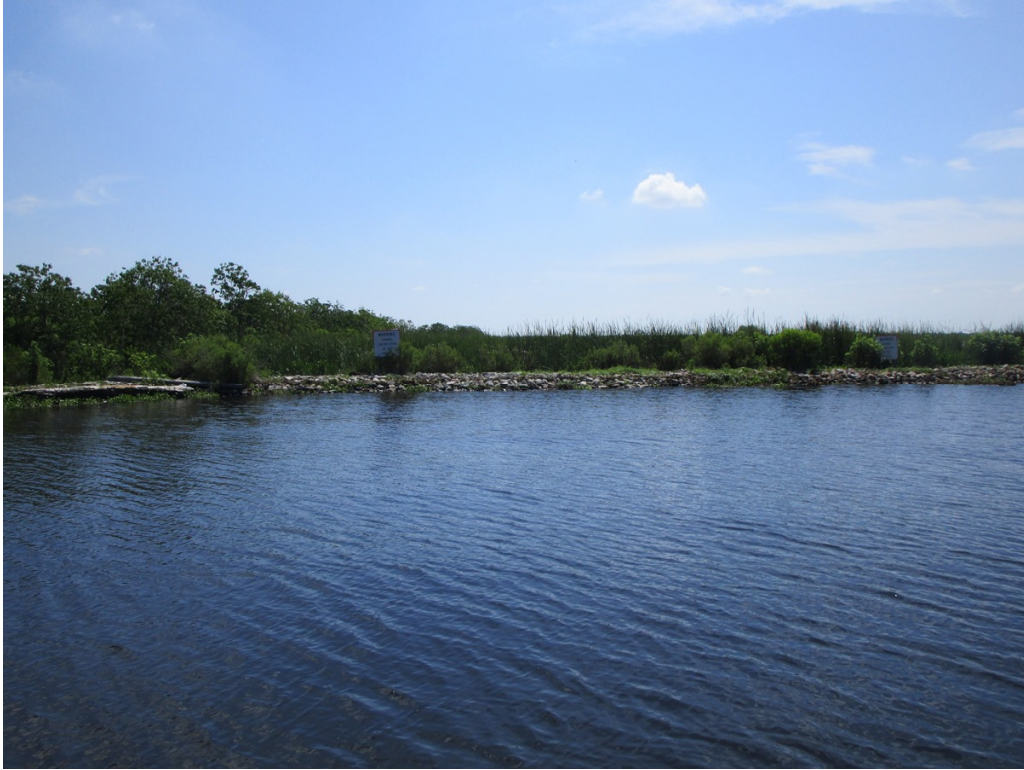
Photo #13 – Structure 21

No significant defects were noted. Structure is generally in good condition and requires no maintenance at this time.

Item	Condition	Physical Damage	Corrosion	Photo #	Observations and Remarks
Signage and supports	Good	None	None	13	
Armored Plug	Good	None	N/A	13	Maintenance is not required at this time.
Construction Unit No.1 Structure Description: 83 linear ft. of rock rip-rap armored rock filled plug located north of Bayou Rigolettes, west of Bayou Barataria, and east of Bayou Perot. The plug crest was constructed to an elevation of +4.0 ft. NGVD. The rock filled plug contains 285 tons of rock fill and 220 tons of rock rip-rap armor. Two (2) aluminum warning signs supported by galvanized pipe are located on each end of the structure through the rock embankment.
